Inspection reference: 021720MG1

Confidential Inspection Report

February 17, 2020

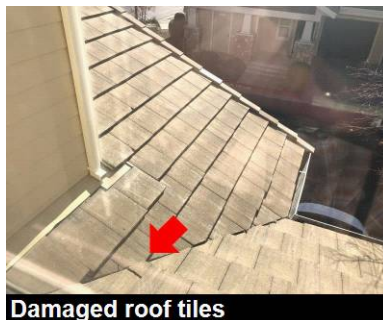
1. [FE] There are a number of cracked, broken and displaced tiles on the roof. These conditions are conducive to roof leaks.

[FE] There are a number of cracked, broken and displaced tiles on the roof. These conditions are conducive to roof leaks.

2. [FE] Given the condition(s) present; we recommend further evaluation with written findings and costs to correct by a qualified, licensed professional roofing contractor (C39).

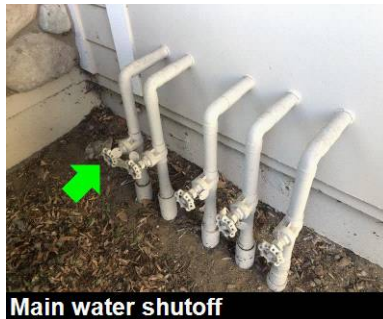
The main water shutoff valve is located at the right side of the building.

Main water shutoff

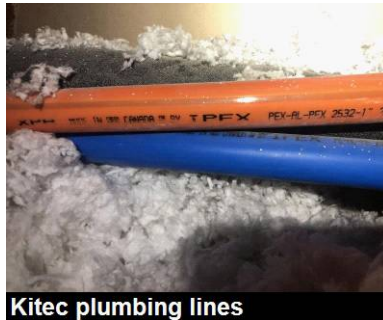
3. [FE] KITEC, NIBCO or ZURN brand water supply fittings and piping observed in the attic. This brand of piping and fittings has been subject to a class-action lawsuit due to its failure rate. While no visible leakage was observed at the time of the inspection, pipe/fitting failure can occur without any visual evidence to suggest it is about to fail. Recommend a qualified, licensed, professional plumbing contractor provide cost estimates to replace the water supply piping in the home before the end of your inspection period. For settlement purposes only, the Settling Parties have agreed to the Courts' certification of the following classes of Persons in regard to claims regarding the Kitec System (which may consist of components, individual parts, or as a system, PEX-AL-PEX, PE-AL-PE, PERT-AL-PERT, PEX pipe, valves, fittings, and/or components, manufactured by or on behalf of IPEX whether sold under the names Kitec, PlumbBetter, IPEX AQUA, WarmRite, Kitec XPA, AmbioComfort, XPA, KERR Controls, Plomberie Améliorée or otherwise). More information can be found at www.kitecsettlement.com.

Kitec plumbing lines

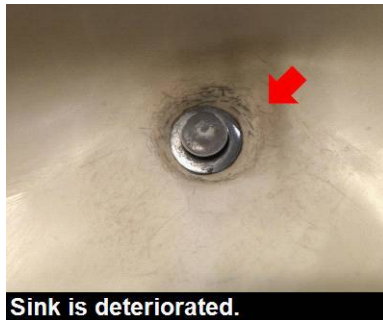
[CR] The master bedroom sink is deteriorated.

Sink is deteriorated.

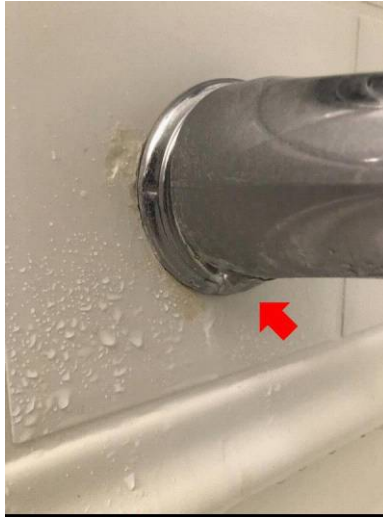
[CR] The tub-to-shower diverter(s) failed to fully divert the water flow to the showerhead.

[CR] The tub spout in master bathroom is leaking.

**Divertor leaking**

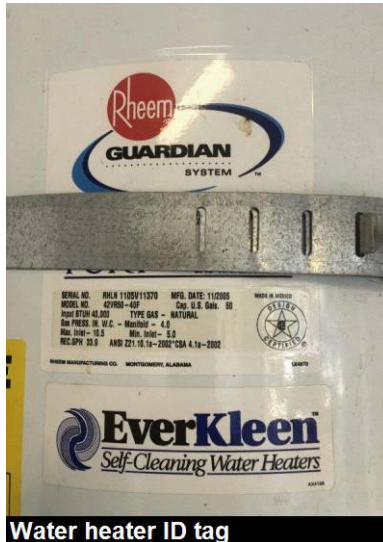
Rheem.

**Water heater ID tag**

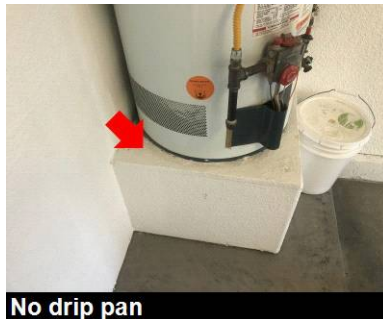
- 540 CONTROLS The temperature control is set in the "normal range" and the water at the faucets is warm/hot.
- 541 LOCATION A vehicle impact barrier is present and appeared functional, with exceptions.
[RU] There is no drip pan and drain line under the water heater to catch and divert any dripping water to the exterior/approved location (not crawlspace). We recommend a pan and drain line be installed for water heaters located in interior spaces.

No drip pan

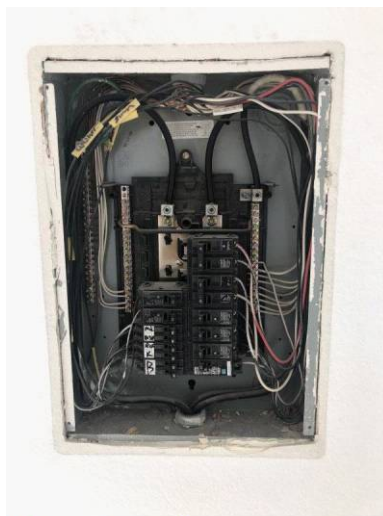
| 615 LOCATION | Located in bedroom #1. |

Main sub panel

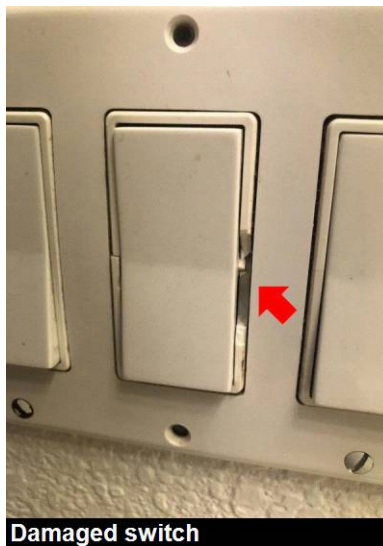
[CR] Switch(s) are damaged at master bathroom.

Damaged switch

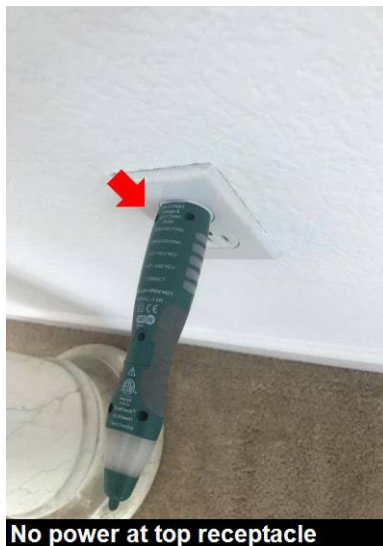
[CR] There is no power at the receptacle(s) located at family room switched hot.

No power at top receptacle

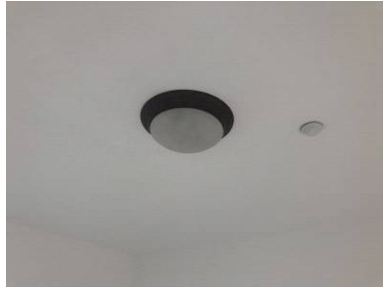
Fixture in bedroom #1

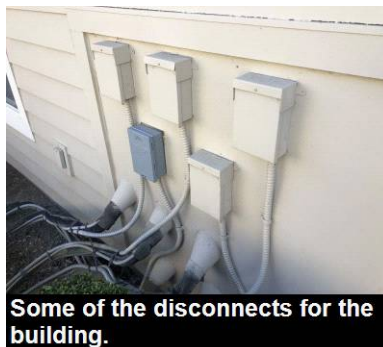
717 LOCATION(S)	The units for the building are located in two clusters on the opposite side of the larger building. The unit for the property is not labeled and therefore not identifiable.
-----------------	--

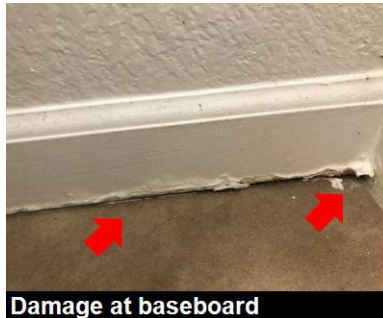
12. [FE] Moisture stains and damage observed on the baseboard in the hall bathroom. We recommend locating and correcting the source and any damaged materials.

[FE] Moisture stains and damage observed on the baseboard in the hall bathroom.
We recommend locating and correcting the source and any damaged materials.

Damage at baseboard

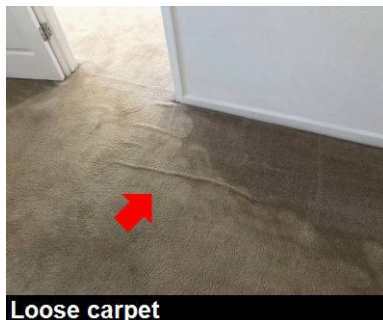
[CR] The carpet is loose from the floor at the master bedroom.

Loose carpet

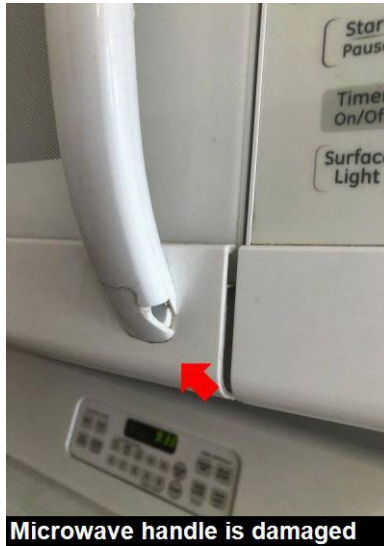
1. [SC] The door/handle is damaged/missing.

- 950 GARBAGE DISPOSAL(S) The garbage disposal(s) functioned.
- 951 MICROWAVE(S) The microwave oven functioned, with exceptions.
[SC] The door/handle is damaged/missing.

Microwave handle is damaged

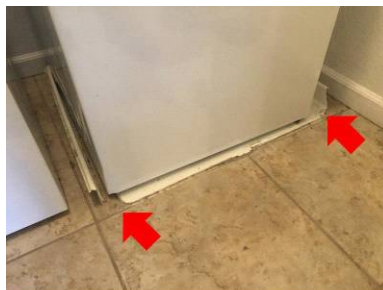
[CR] The leak pan/drain pan for the washing machine in the second story laundry area is damaged.

Damaged drain pan

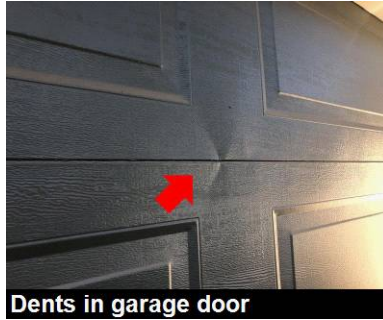
[CR] The garage door has small dents.

Dents in garage door
