Inspection reference: 1237

Confidential Inspection Report

**8341 Nowhere Dr.
Sacramento CA 95817**

September 5, 2019

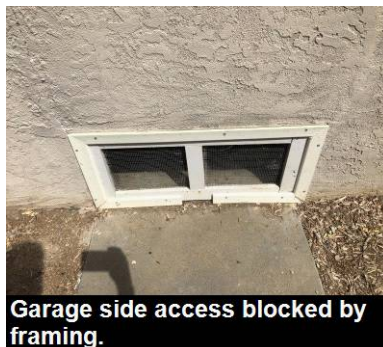
- 115 ACCESSIBILITY Located from the exterior at the left side of the building and the back side of the building. The crawl space was viewed from the access opening only, this is a limited inspection. [CR] Crawl space is too low to fully enter and inspect.

Garage side access blocked by framing.

[FE] Given the condition(s) present, we recommend full evaluations and/or corrections with written findings and costs to cure by the appropriate professionals in the appropriate trades. Recommend creating a new access opening with a minimum size of 22 inches x 30 inches'

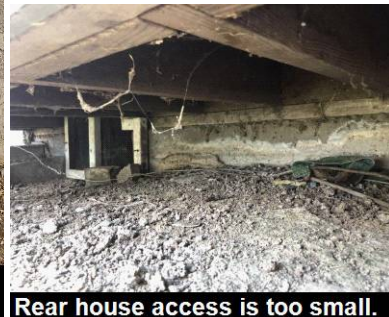
Rear house access is too small.

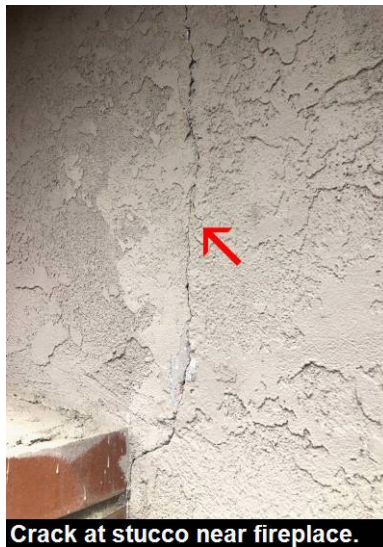
[CR] There are cracks in the stucco siding. These conditions are conducive to moisture intrusion/deterioration.

[FE] Portions of the metal stucco weep screed along the bottom edge of the stucco siding lacked adequate clearance from or are buried in the ground. These conditions are conducive to moisture intrusion/deterioration.

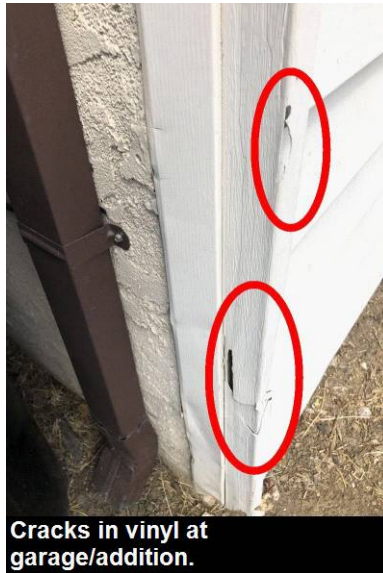
The manufactured siding appeared functional, with exceptions. [CR] There are cracks/holes in the manufactured siding. These conditions are conducive to moisture intrusion/deterioration.

Cracks in vinyl at garage/addition.

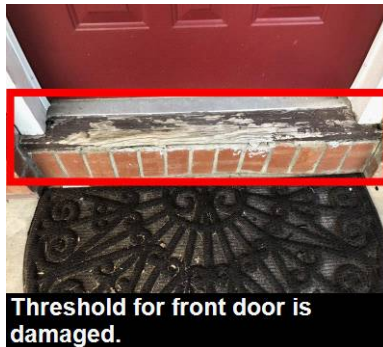
[FE] There are damaged/deteriorated trim materials.

Threshold for front door is damaged.

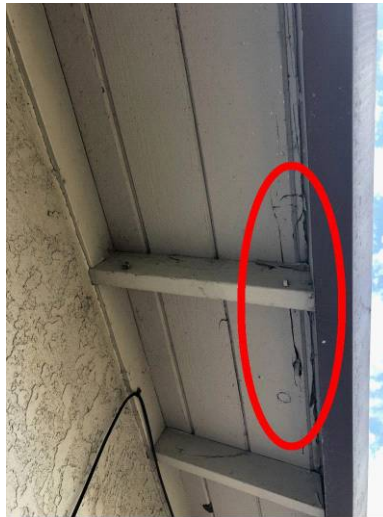
[FE] There are damaged/deteriorated eave and soffit materials.

**Damage at eave.**

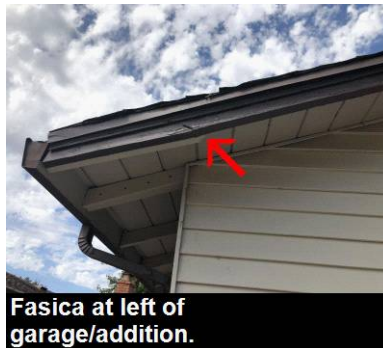
The observed fascia materials appeared functional, with exceptions. [FE] There are damaged/deteriorated fascia materials.

**Fasica at left of garage/addition.**

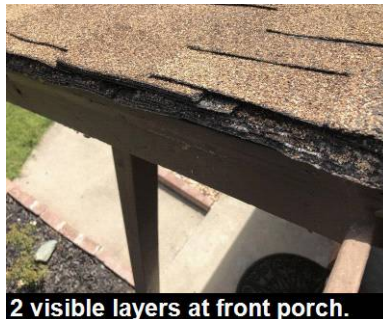
There are an undetermined number of layers.

2 visible layers at front porch.

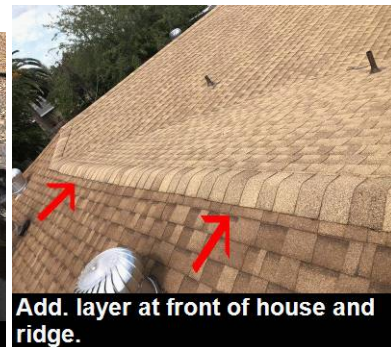
Add. layer at front of house and ridge.

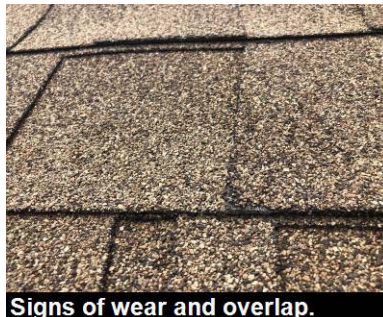
- a. [FE] The roof shingle head lap (overlap of the shingle above to the shingle below) is less than the manufacturer's installation guidelines.

Signs of wear and overlap.

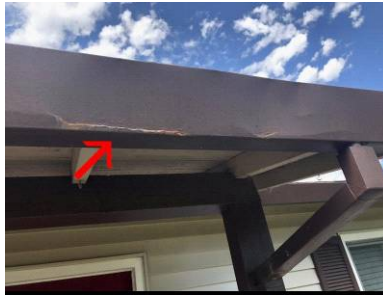
- [CR] The gutters are rusting in areas.

Rust at gutter over entry.

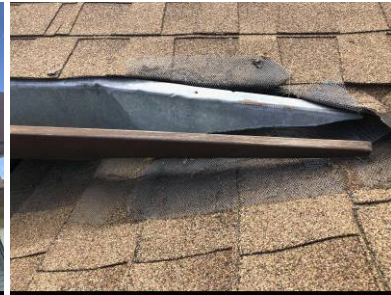
[CR] The rain gutters are loose from the building.

Loose gutter at valley.

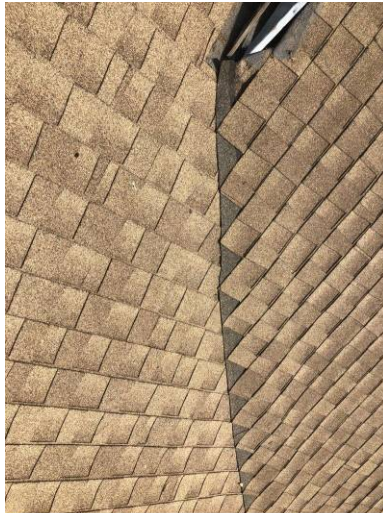
[CR] There are substandard, damaged or missing flashings at the valley(s)

Valley not interwoven.

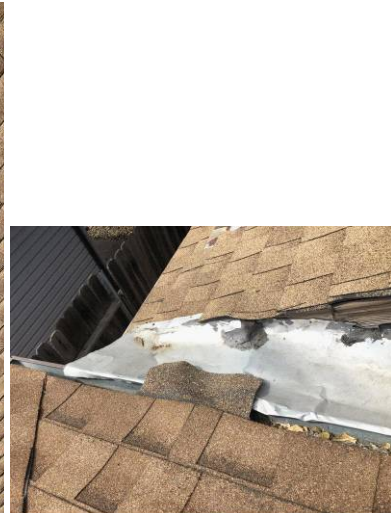
[CR] There are substandard, damaged or missing flashings between the main house and laundry shed, we recommend correcting the condition(s) noted.

Previous repair betewwn roofs.

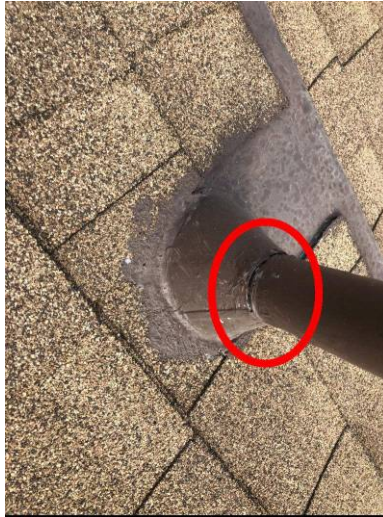
[CR] The roof penetrations are not sealed at several locations. We recommend correcting the condition(s) using approved methods.

No seal at vent.

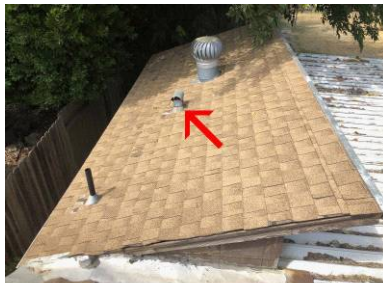
[CR] There are rusted-out/damaged/deteriorated flue pipe cap(s).

Rusted flue pipe.

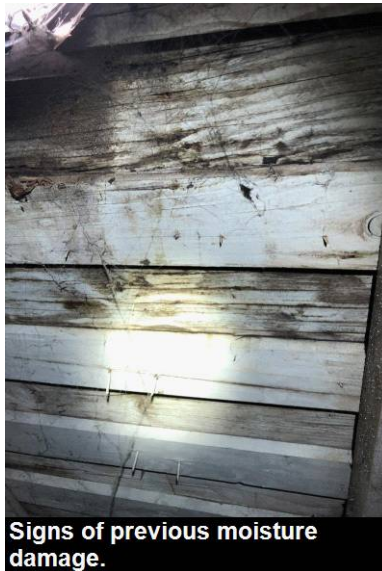
a. [FE] Moisture stains and damage observed on the sheathing, currently dry. |

Signs of previous moisture damage.

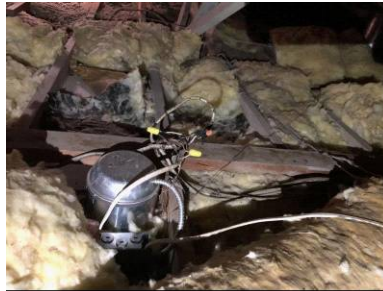
[CR] Attic hatch not insulated. [RU] The attic space has minimal insulation installed by today's standards. We recommend installing additional insulation for energy efficiency as an upgrade.

Inconsistent insulation levels.

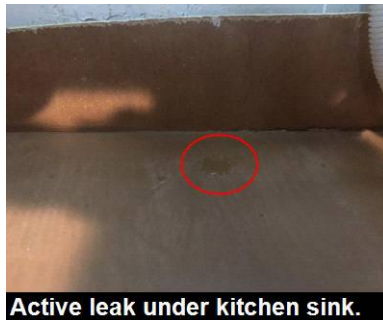
The observed drain pipes are functional. [CR] The sink drain(s) at bathrooms are slow or blocked. [CR] Active leaks observed at the waste pipes.

Active leak under kitchen sink.

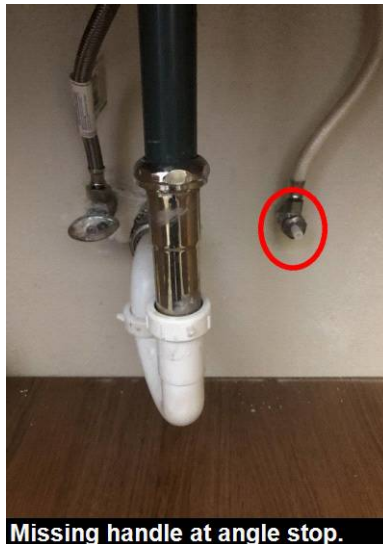
The faucets and piping appeared functional. [CR] Several sink angle stops are missing handles.

Missing handle at angle stop.

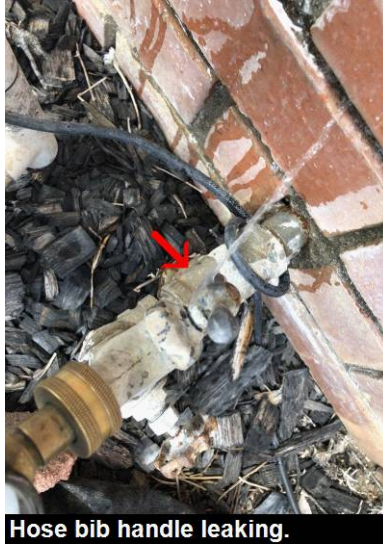
[CR] The front hose faucet leaked at the handle when operated.

Hose bib handle leaking.

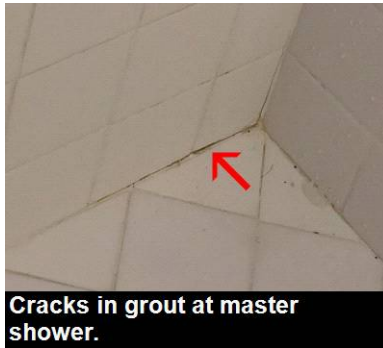
a. [CR] The grout/caulking is cracked or missing in master bathroom. We recommend correcting this condition to prevent moisture intrusion into concealed spaces.

Cracks in grout at master shower.

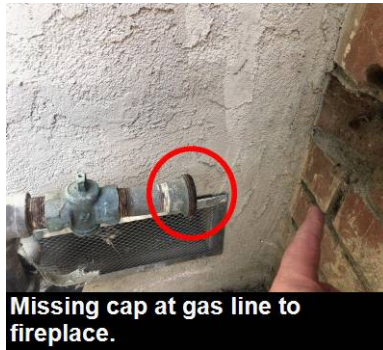
[SC] Rear exterior gas line is not capped at the shutoff valve/connector.

Missing cap at gas line to fireplace.

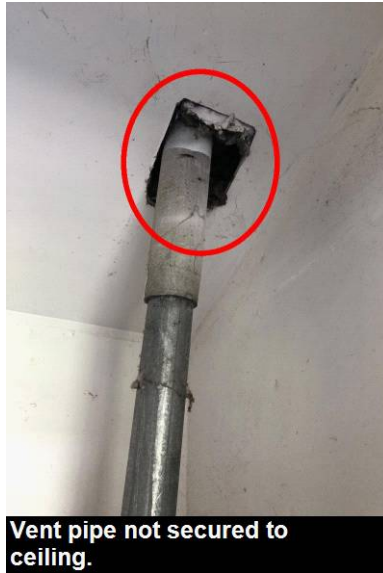
[SC] There was no collar/bucket to separate the flue vent pipe from the sheetrock ceiling. The collar/bucket is needed to provide adequate clearance to minimize heat transfer to combustible materials. [SC] Transite (Asbestos) vent piping.

Vent pipe not secured to ceiling.

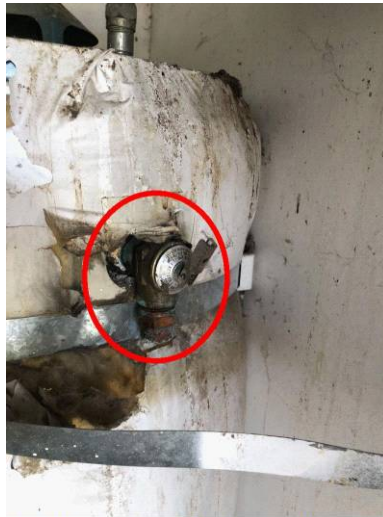
[SC] The temperature & pressure relief valve's discharge line is missing. We recommend installing an approved discharge line that extends to the exterior and terminates close to the ground facing downward.

TPRV missing discharge line.

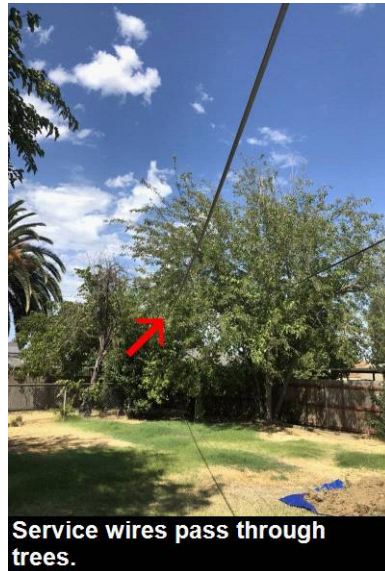
| 607 SERVICE WIRING | The overhead service wires and weatherhead appeared to be functional, [CR] Tree branches are in contact with the overhead service entrance cables. |

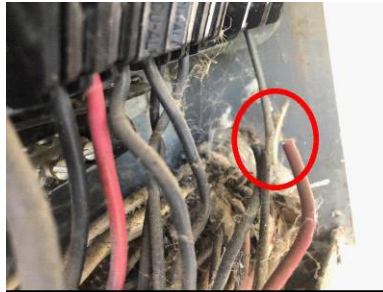
[SC] There are disconnected wires in the panel, these should be traced to unsure they are not part of existing circuits that could be energized.

Disconnected wires in panel.

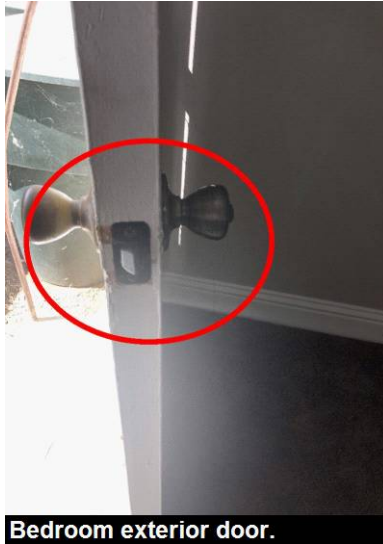
915 INTERIOR DOOR(S)	The door(s) are functional with exceptions. [CR] The doors rubbed at middle bedroom.
916 EXTERIOR DOOR(S)	The door(s) are functional with exceptions. [SC] The bedroom addition exterior door has a standard entry lock but does not have a deadbolt lock. We recommend correcting the condition for security reasons. [CR] The door did not close squarely or seal tightly, the door was also under the standard height of 80 inches.

Bedroom exterior door.

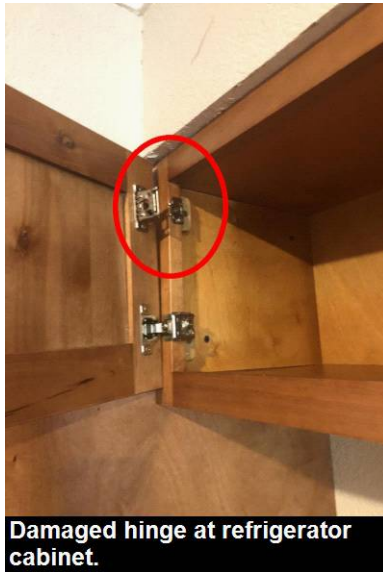
[CR] The door(s)/drawer(s) did not operate smoothly or close properly.

Damaged hinge at refrigerator cabinet.
