**Inspection reference: 021720MG1**

# Confidential Inspection Report

**February 17, 2020**

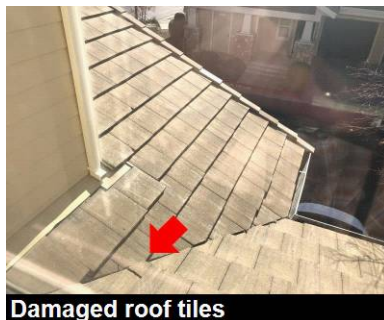
**[FE] There are a number of cracked, broken and displaced tiles on the roof. These conditions are conducive to roof leaks.**

2. [FE] Given the condition(s) present; we recommend further evaluation with written findings and costs to correct by a qualified, licensed professional roofing contractor (C39).

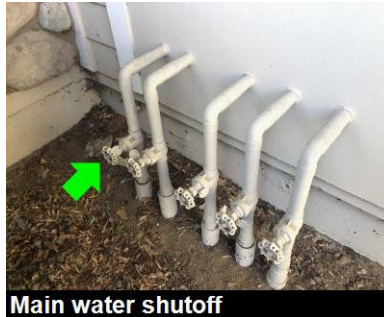
**Main water shutoff**

The main water shutoff valve is located at the right side of the building.

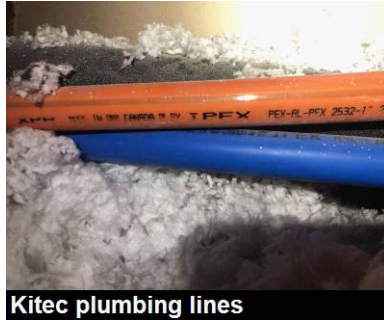
[or otherwise\). More information can be found at www.kitecsettlement.com.](http://www.kitecsettlement.com)

3. [FE] KITEC, NIBCO or ZURN brand water supply fittings and piping observed in the attic. This brand of piping and fittings has been subject to a class-action lawsuit due to its failure rate. While no visible leakage was observed at the time of the inspection, pipe/fitting failure can occur without any visual evidence to suggest it is about to fail. Recommend a qualified, licensed, professional plumbing contractor provide cost estimates to replace the water supply piping in the home before the end of your inspection period. For settlement purposes only, the Settling Parties have agreed to the Courts' certification of the following classes of Persons in regard to claims regarding the Kitec System (which may consist of components, individual parts, or as a system, PEX-AL-PEX, PE-AL-PE, PERT-AL-PERT, PEX pipe, valves, fittings, and/or components, manufactured by or on behalf of IPEX whether sold under the names Kitec, PlumbBetter, IPEX AQUA, WarmRite, Kitec XPA, AmbioComfort, XPA, KERR Controls, Plomberie Améliorée or otherwise). More information can be found at [www.kitecsettlement.com](http://www.kitecsettlement.com).

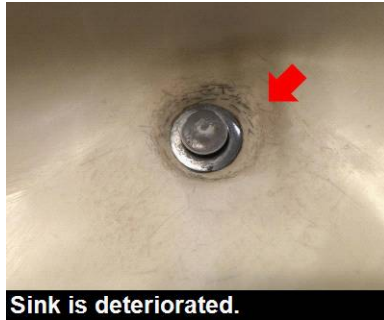
**[CR] The master bedroom sink is deteriorated.**

**Sink is deteriorated.**

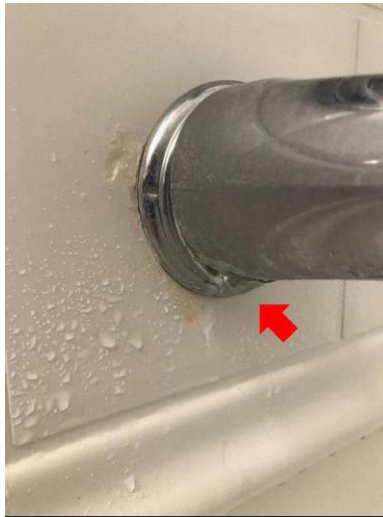
**[CR] The tub-to-shower diverter(s) failed to fully divert the water flow to the showerhead.**

**[CR] The tub spout in master bathroom is leaking.**

**Divertor leaking**

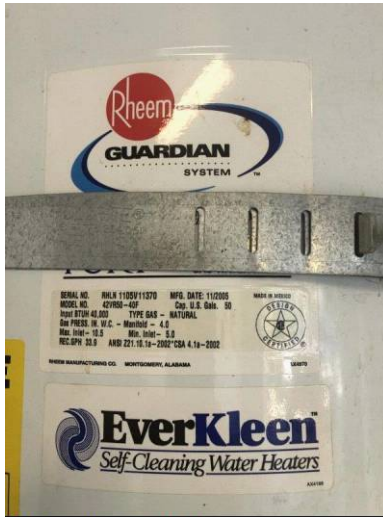
The water heater is located in the garage.  
Rheem.

**Water heater ID tag**

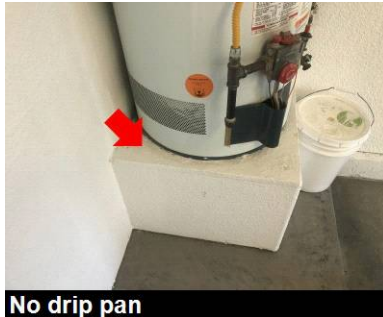
**[RU] There is no drip pan and drain line under the water heater to catch and divert any dripping water to the exterior/approved location (not crawlspace). We recommend a pan and drain line be installed for water heaters located in interior spaces.**

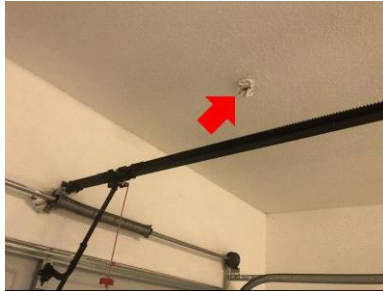
554 FIRE SPRINKLER(S) **[FE] These systems are outside the scope of the inspection and are not inspected. These systems require regular inspections and testing every 5 years. There are a number of different fire sprinkler heads in use today that are known to be defective. We recommend requesting all available informational material (original documentation and warranty) for the system from the current homeowners as well as consulting with a qualified, licensed professional fire protection contractor (C16) to learn more about the defective makes and models, inspection and testing.**  
**[CR] There are sprinkler head trim rings/covers missing and/or covered with tape for painting.**

Sprinkler heads are taped up

5. [FE] These systems are outside the scope of the inspection and are not inspected. These systems require regular inspections and testing every 5 years. There are a number of different fire sprinkler heads in use today that are known to be defective. We recommend requesting all available informational material (original documentation and warranty) for the system from the current homeowners as well as consulting with a qualified, licensed professional fire protection contractor (C16) to learn more about the defective makes and models, inspection and testing.

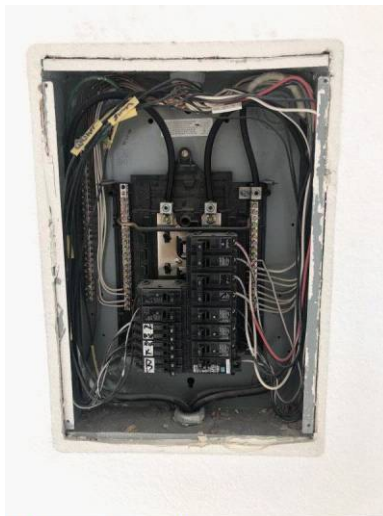
- 615 LOCATION                            Located in bedroom #1.

**Main sub panel**

- 616 PANEL RATING                        120/240 volt, rated at 125 Amperes maximum, service rating is undetermined.
- 617 DISCONNECT TYPE                    Circuit breakers  
110V Circuits: 12  
220V Circuits: 02  
AFCI (Arc Fault Circuit Interrupter) Circuits: 01.

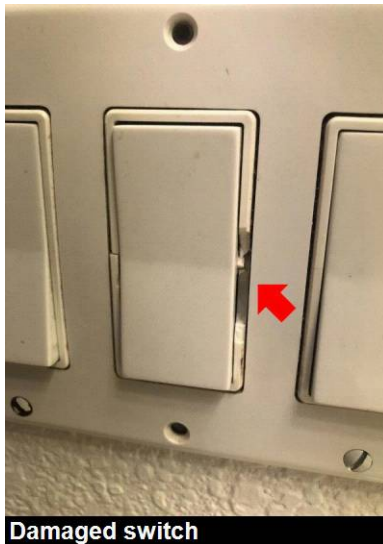
[CR] Switch(s) are damaged at master bathroom.

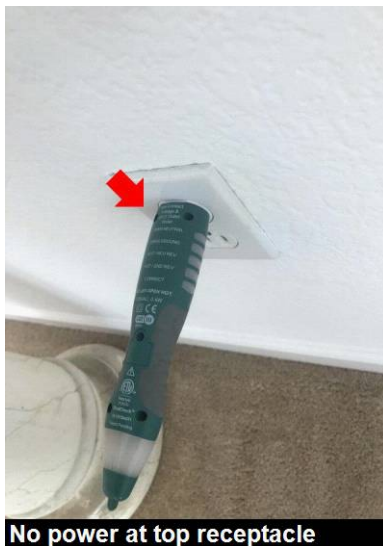
[CR] There is no power at the receptacle(s) located at family room switched hot.

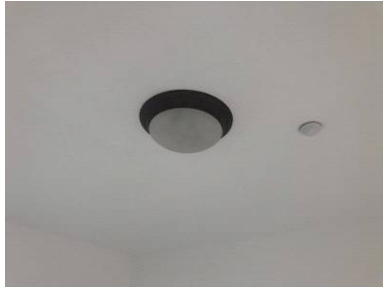
and/or failed fixture?)

Fixture in bedroom #1

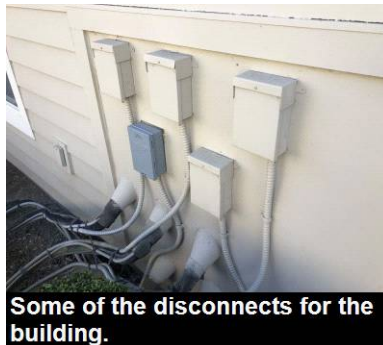
717 LOCATION(S)	The units for the building are located in two clusters on the opposite side of the larger building. The unit for the property is not labeled and therefore not identifiable.
-----------------	--

718 BRAND	Unknown, ID tag missing or illegible.
719 MANUFACTURE DATE	The unit appeared to be original equipment with the building.
720 SYSTEM TYPE(S)	"Split system" The condensing unit and evaporator coils are at different locations.
721 APPROX. SIZE(S)	Unknown, ID tag missing or illegible.

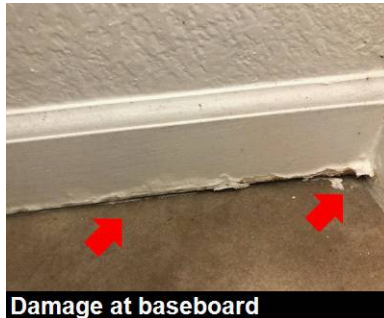
**[FE] Moisture stains and damage observed on the baseboard in the hall bathroom. We recommend locating and correcting the source and any damaged materials.**

**Damage at baseboard**

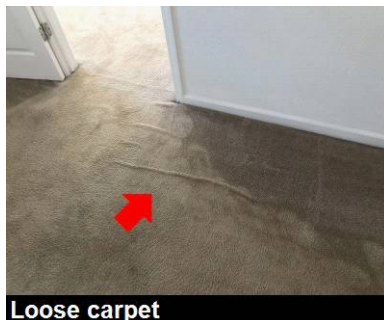
**[CR] The carpet is loose from the floor at the master bedroom.**

**Loose carpet**

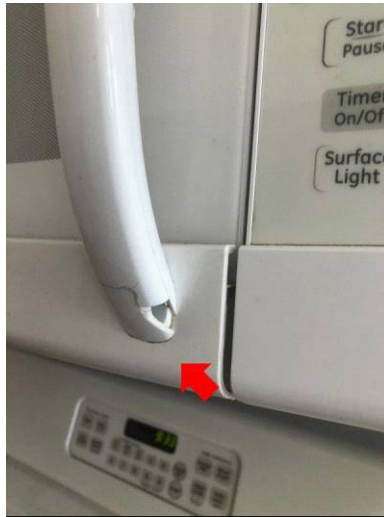
- 950 GARBAGE DISPOSAL(S) The garbage disposal(s) functioned.
- 951 MICROWAVE(S) The microwave oven functioned, with exceptions.  
**[SC] The door/handle is damaged/missing.**

**Microwave handle is damaged**

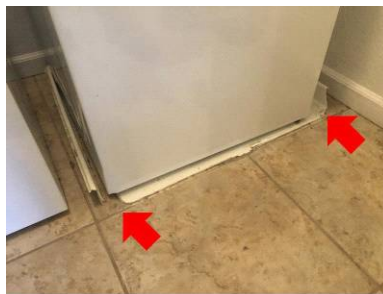
985 WASHER SERVICE **[NOTE]** Clothes washing machine appliances are outside the scope of the inspection and are not inspected. If the appliance is included in the transfer of the home, we recommend requesting all available informational material (original documentation and warranty) for the system from the current homeowners regarding the operation and maintenance of this system.  
The laundry faucets appear functional, no leaks observed, a machine is connected. We do not operate the faucets.  
**[CR]** The leak pan/drain pan for the washing machine in the second story laundry area is damaged.

**Damaged drain pan**

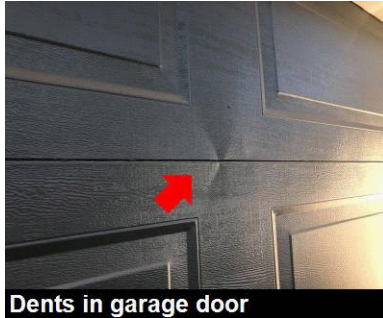
[CR] The garage door has small dents.

**Dents in garage door**
