Inspection reference: 021720MG1

Confidential Inspection Report

February 17, 2020

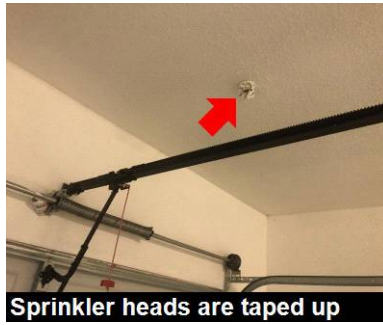
- 554 FIRE SPRINKLER(S) [FE] These systems are outside the scope of the inspection and are not inspected. These systems require regular inspections and testing every 5 years. There are a number of different fire sprinkler heads in use today that are known to be defective. We recommend requesting all available informational material (original documentation and warranty) for the system from the current homeowners as well as consulting with a qualified, licensed professional fire protection contractor (C16) to learn more about the defective makes and models, inspection and testing.
[CR] There are sprinkler head trim rings/covers missing and/or covered with tape for painting.
